AUDIT REPORT

REVIEW OF NASA'S EXPLOSIVES SAFETY PROGRAM

OFFICE OF INSPECTOR GENERAL

National Aeronautics and
Space Administration

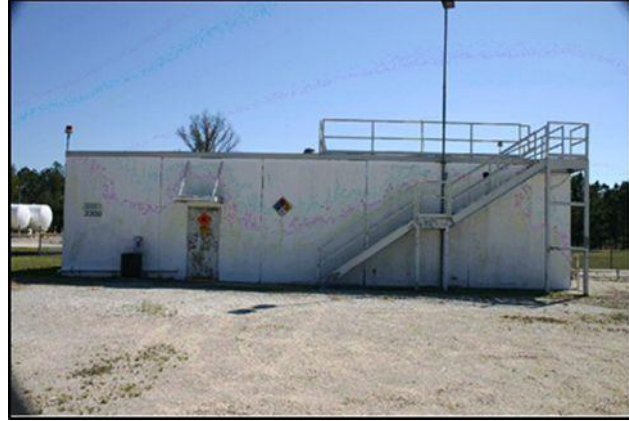
Figure 5. Explosives storage facility building

miscalculation of the safe separation distance between the energetic materials and other occupied buildings. Specifically, high-order, mass detonating explosive material was improperly co-located with pyrotechnic explosive devices sensitive to ignition. Personnel and property were placed at great risk because the quantity and type of explosive materials exceeded the design constraints of the building and the facility was located too close to an adjoining building. Based on calculations by a Department of Defense subject matter expert, if the stored material detonated, 42 percent of a nearby occupied building would have sustained structural damage and 15 percent of the personnel inside could have sustained fatal injuries.²⁴

Third, testing was being performed with energetic materials that were incompatible with the materials stored in the building. Specifically, the building was being used to conduct testing involving electro-explosive devices. Although personnel were protected by a bullet-proof shield, the design did not meet NASA standards for concurrent operations.

Fourth, pyrophoric material was being improperly stored outside of the building; specifically, the material was not stored in fire-proof containers. Moreover, the storage area violated the required safe separation distance from the explosives stored within the building.²⁵ Pyrophorics are toxic, extremely volatile, and highly reactive chemicals that can spontaneously combust when exposed to moisture in the air. If this material ignited unintentionally, the ensuing fire could potentially spread to the area in the inadequately designed building where other explosive materials were stored.

The ESO is required to review, validate, and approve all energetic material operations and processes, facility site plans, and explosive site licenses. However, the ESO's lack of knowledge and experience in explosives safety, in our judgment, not only contributed to these violations, but permitted these deficiencies to remain uncorrected.

Following our visit, Stennis personnel removed the high-order explosive materials from the facility, thereby negating the immediate threat to other buildings and personnel. Additionally, inappropriate indoor storage magazines were being replaced, the grounding system reevaluated, and the surge and lightning protection system redesigned. Furthermore, measures were underway to improve the outdoor storage area for the pyrophoric materials and to install an appropriate fire wall to separate the storage area from the rest of the facility.

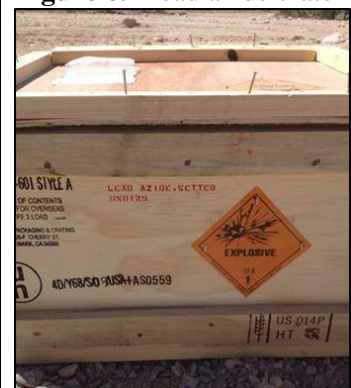
Figure 6. Lead azide crate

White Sands. We observed two wooden shipping crates containing dextrinated lead azide (lead azide), the quantity and condition of which was unknown by site personnel (see Figure 6). Lead azide is a highly toxic, high-order, mass detonating explosive that is extremely sensitive to impact, friction, and static electricity and can detonate if dropped from heights as low as 6 inches. Many energetic materials, including lead azide, become increasingly unstable and more susceptible to detonation as they age. However, it is extremely difficult to predict at what point the material becomes so unstable that it could explode.

The ESO opened the crates, each of which contained 25 separate compartments. All 25 compartments in the first crate were filled with sealed bags containing 50 grams each of lead azide. The second crate had 19 compartments containing lead azide, 18 of which were filled with bags containing 50 grams and 1 filled with 2.6 grams of the material. A few of the bags were inflated similar to a balloon, causing concern regarding the condition of the chemical.

The DOT Code of Federal Regulations requires that lead azide be shipped and stored in a "wetted" condition – not less than 20 percent water or a water-alcohol mixture – and cautions that once the material dries out it becomes highly unstable and sensitive to detonation. Some of the bags appeared to contain yellowish brown residue, indicating

that the material may have dried out and possibly crystallized. Lead azide is most sensitive to detonation in this state.

In our opinion, had the ESO not opened the crates, the condition of the lead azide would have remained unknown, placing personnel attempting to transport or handle this sensitive material at high risk. Any sudden movement would likely have resulted in an explosion causing death, serious injury, or damage to equipment and facilities. Given the severity of the hazard, on-site safety personnel destroyed the material after our departure from the facility.

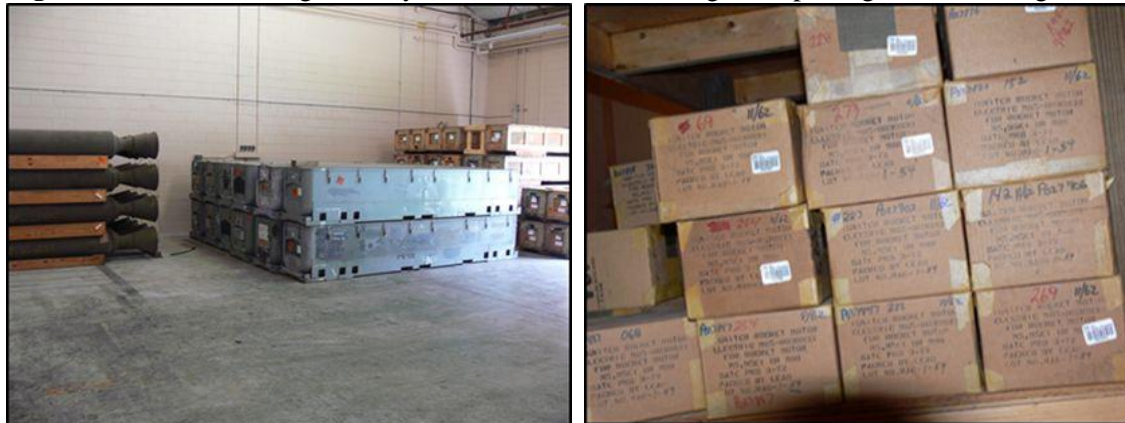
Figure 7. A rocket storage facility (left) and rocket motor igniters packaged in 1972 (right)

manufactured between the late 1950s and early 1970s. The stacked placement, coupled with the unknown condition of the propellant, increased the probability of a catastrophic event because if a single rocket were to ignite or explode this could set off a chain-reaction of detonations.

We observed hundreds of rockets stacked closely together in bunkers, test, and storage facilities, most of which had not been inspected by the ESO in at least the past 2 years (see Figure 7). The stacked placement increased the probability of a catastrophic event because if a single rocket were to ignite or explode it could set off a chain-reaction or series of multiple detonations. The ESO stated that he did not have the resources to inspect and evaluate the rockets.

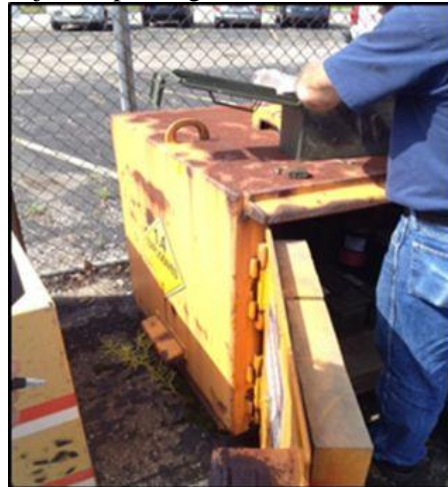
Figure 8. Explosive storage and adjacent parking lot

- At Glenn, a storage magazine containing pyrotechnics used in support of aircraft flight operations was in poor condition and located too close to an adjoining parking lot.

Glenn. At Lewis Field, we observed a portable storage magazine that was in poor condition, and inappropriately positioned along the fence line of a parking lot where it posed a potential danger to personnel and vehicles (see Figure 8). In addition, we identified improper grounding of the electrostatic discharge workstation used to service aircraft ejection seats and canopies. In the same area, we observed prohibited items such as plastic packaging materials and tape capable of producing a static charge that could cause inadvertent detonation of static-sensitive pyrotechnics or electro-explosive devices.

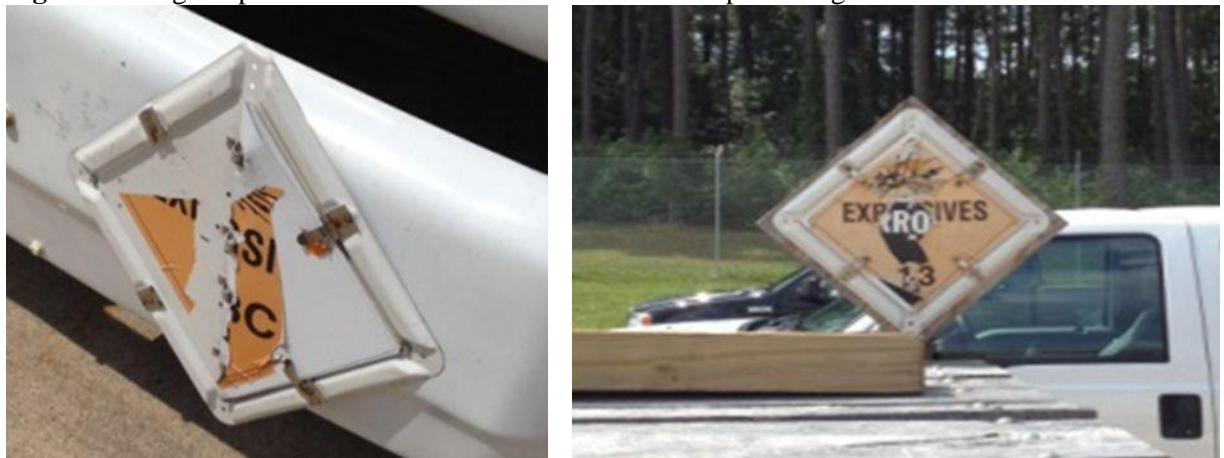
Figure 9. Illegible placards on vehicles that are used to transport energetic material

No Record of Vehicle Inspections. NASA policies establish detailed safety standards, requirements, and guidelines for vehicles used to transport energetic materials. The presence of potential ignition sources (heat or electrical spark) and exposure to mechanical vibration and shock during motor transport necessitate that all vehicles used to transport energetic materials be inspected prior to use. We inspected vehicles used to transport energetic materials to determine whether they met requirements that ensure the safety of drivers and passengers, the energetic materials, surrounding personnel, and the environment. Except for minor discrepancies such as illegible placards, the majority of vehicles met the requirements and appeared to be properly maintained (see Figure 9). However, no inspection records were being kept for these vehicles.

The ESOs told us that vehicle inspections are performed prior to loading and transporting energetic materials. However none of the sites we visited could produce inspection records or checklists of these inspections. The Department of Defense has a general vehicle safety checklist that meets the DOT requirements for transport of hazardous materials.²⁹ In our judgment, it would be a best practice for NASA to utilize a similar checklist to help ensure that critical safety systems on vehicles used to transport energetic materials are in safe working order.
