IG-01-042

**AUDIT
REPORT**

**SAFETY OF LIFTING DEVICES AND
EQUIPMENT AT STENNIS SPACE CENTER**

September 28, 2001

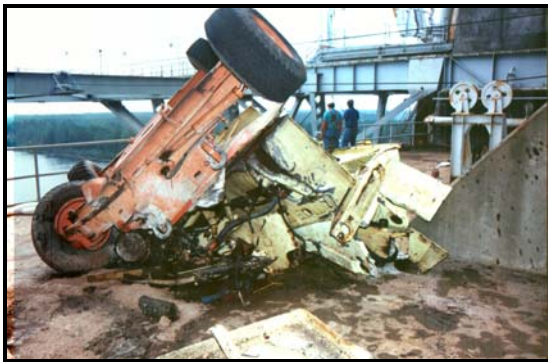
The man-lift, which will cost NASA about \$130,000 to replace, was completely destroyed, and the test stand sustained an estimated \$40,000 in damage. NASA incurred additional costs of about \$33,000 for other incidental expenses such as environmental cleanup, removal of the destroyed man-lift, and minor repairs to a damaged Government vehicle.¹² Figures 1 and 2 show the destroyed man-lift on the sixth level of the test stand.

Figure 1. View of destroyed man-lift from the sixth level

2000 Lifting Mishap. As described in Finding A, on November 5, 2000, a man-lift fell about 80 feet from the B-Test Stand main derrick because Lockheed-Martin used improper rigging to perform the lift. The mishap resulted in a destroyed man-lift, damage to the stand, and incidental expenses totaling more than \$200,000.

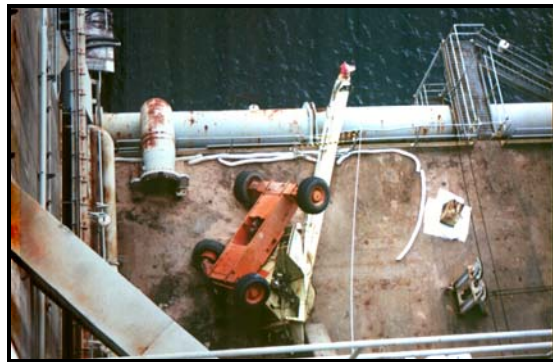
Figure 2. Overhead view of destroyed man-lift

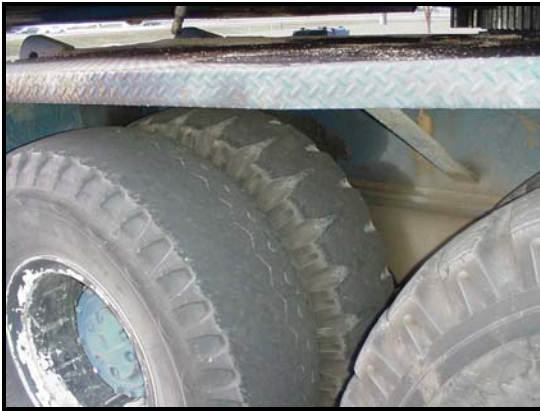
We also observed many mobile cranes with safety and maintenance deficiencies. Some of the more significant crane deficiencies included fluid leaks, badly worn tires, and cracked glass. Figures 3 and 4 show the condition of a mobile crane used almost daily at Stennis.

Figure-3. Bald tires on a 55-ton mobile crane.

During the audit, MSS initiated corrective actions such as replacing tires and cleaning up leaking areas on some cranes.

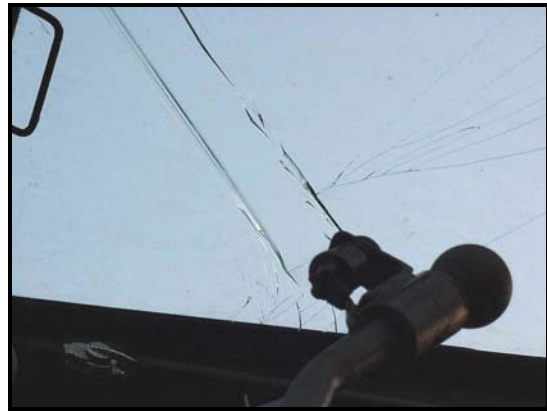
Figure-4. Cracked operator's cab roof glass on a 55-ton mobile crane.
