**SPACE SHUTTLE ORBITER  
WIRING INSPECTION**

**July 14, 2005**

**OFFICE OF INSPECTOR GENERAL**

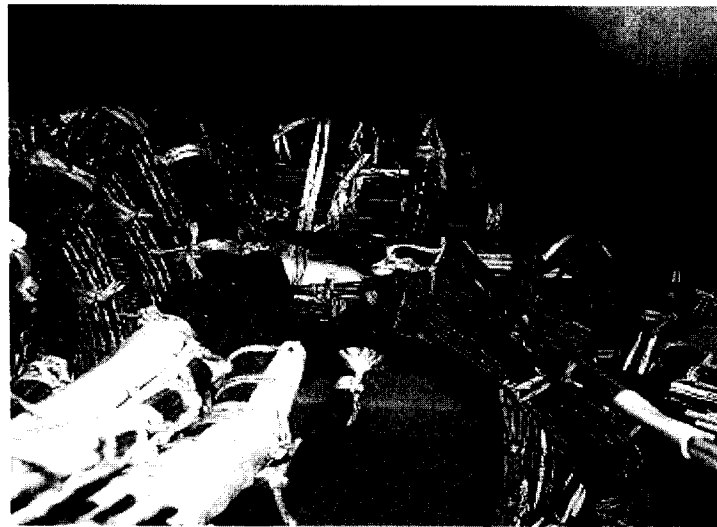
Visual inspections of orbiter wiring involve examining the outer wires of a bundle and not the wires inside the bundle. Wires inside the bundle are inspected only when insulation damage is detected on the outer wires. The inspection then includes a 360-degree check of loose wires and the area of insulation damage. Figure 1 shows wiring bundles within the crew module of the orbiter Atlantis.

**Figure 1. Wiring Bundles Within the Crew Module of Orbiter Atlantis**
