AUDIT REPORT

REVIEW OF NASA'S EXPLOSIVES SAFETY PROGRAM

OFFICE OF INSPECTOR GENERAL

National Aeronautics and
Space Administration

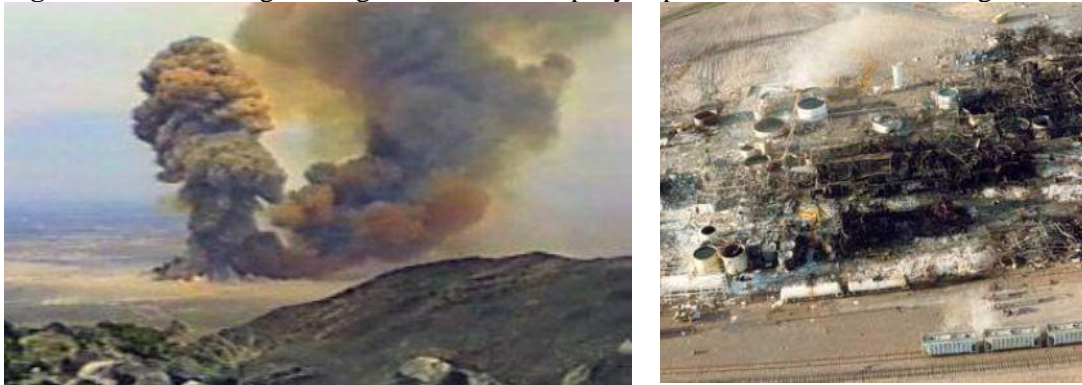
- In May 1988, sparks from a repair crew's welding torch set ablaze a fiberglass structure at a Pacific Engineering Production Company plant in Henderson, Nevada. The flames engulfed a massive stock of ammonium perchlorate, an oxidizer used in solid fuel rocket boosters, creating the largest accidental domestic, non-nuclear explosion in recorded history. The explosion killed 2 employees, injured approximately 372 others, and affected structures within a 10-mile radius. Damages were estimated at \$100 million (see Figure 2).

Figure 2. Pacific Engineering Production Company explosion and resultant damage
