SPACE SHUTTLE PROGRAM PROBLEM REPORTING AND  
CORRECTIVE ACTION PROCESS AT KENNEDY SPACE  
CENTER NEEDS IMPROVEMENT

National Aeronautics and  
Space Administration

REPORT No. IG-06-014 (ASSIGNMENT No. A-5-024-00)

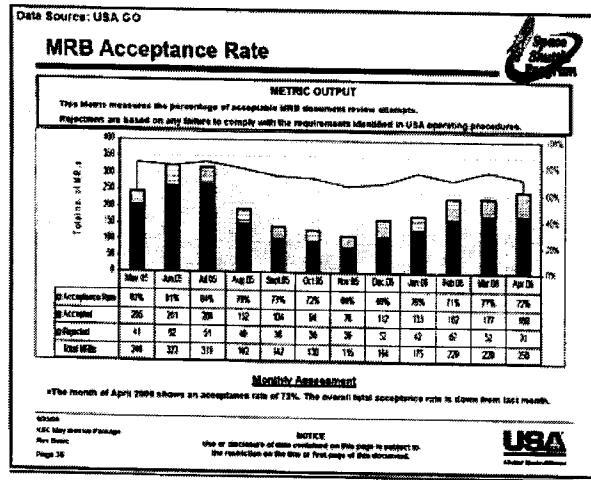
4. **MRB Acceptance Rate:** This metric measures the percentage of acceptable MRB document review attempts by USA QE. Rejections are based on any failure to comply with requirements.

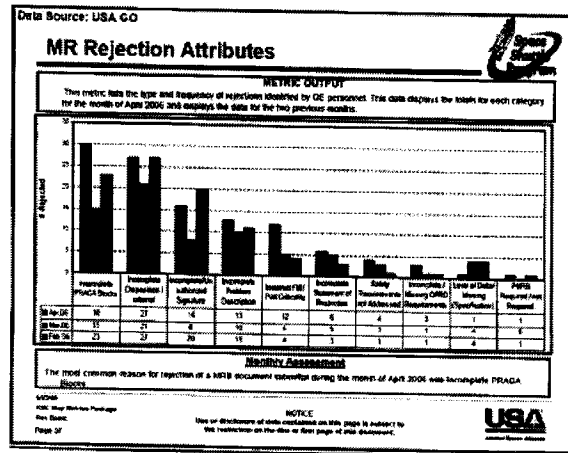
5. **MRB Rejection Attributes:** This metric lists the type and frequency of rejections identified by USA QE personnel. This metric displays the totals for each month and the data for the 2 previous months. Incomplete Problem Description is one possible reason for rejection.
